EPA, THE DEPARTMENT OF THE INTERIOR, AND THE GOLD KING MINE DISASTER

February 11, 2016
Majority Staff Report
Committee on Natural Resources
Chairman Rob Bishop
U.S. House of Representatives
114th Congress

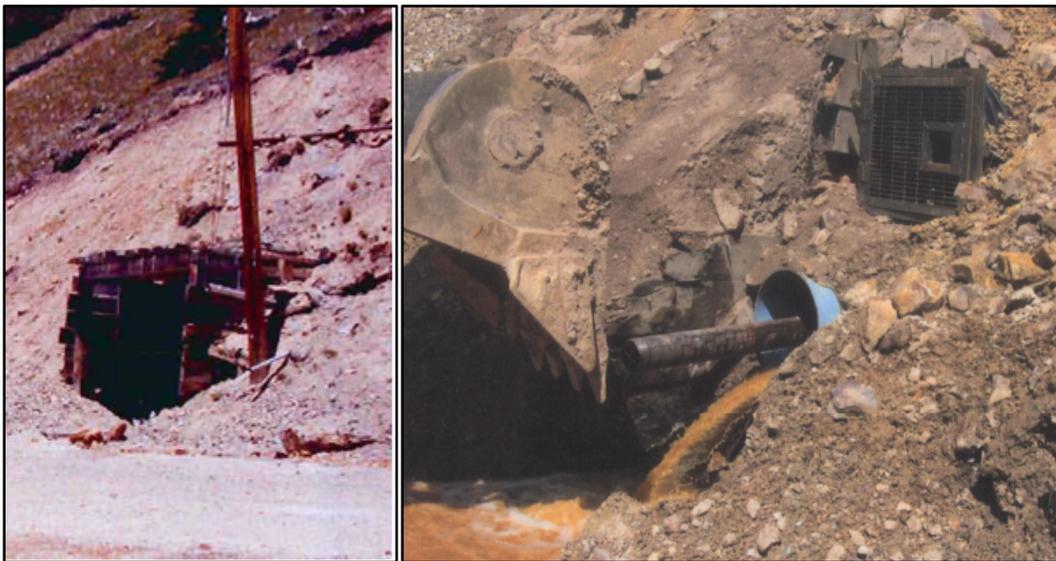
The adit portal (left) prior to DRMS's work in 2009 (right). Source: DRMS.

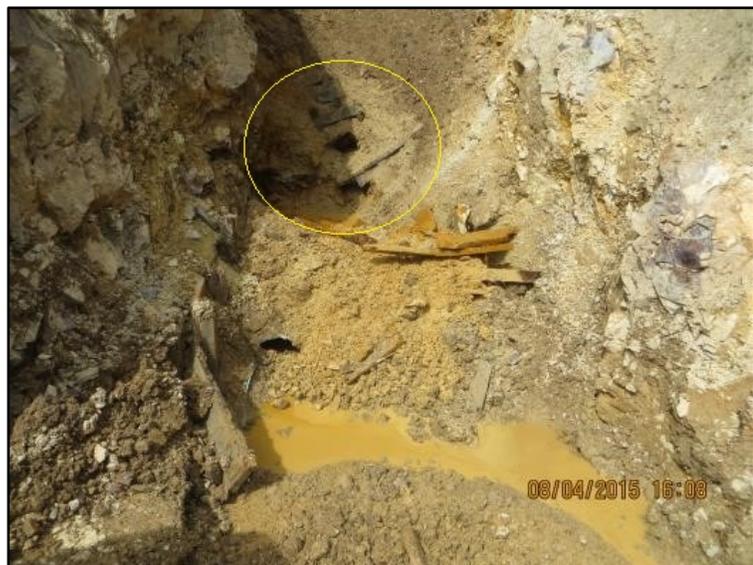
In this photo from 4:08 p.m. on August 4, the EPA crew has unearthed the plug (highlighted in yellow). The end of a section of pipe is visible in the mound in front of the plug. Source: EPA.

compacted clay, sand, and other materials, as well as visible remnants of the portal structure, was *above* the excavated pipes that EPA believed occupied the top four feet of the adit. In other words, the crew discovered that the adit plug was higher than where they thought the roof of the adit was located. At this point, the EPA crew should have realized that their assumptions about the elevation of the adit floor and the location of the pipes were dangerously inaccurate.

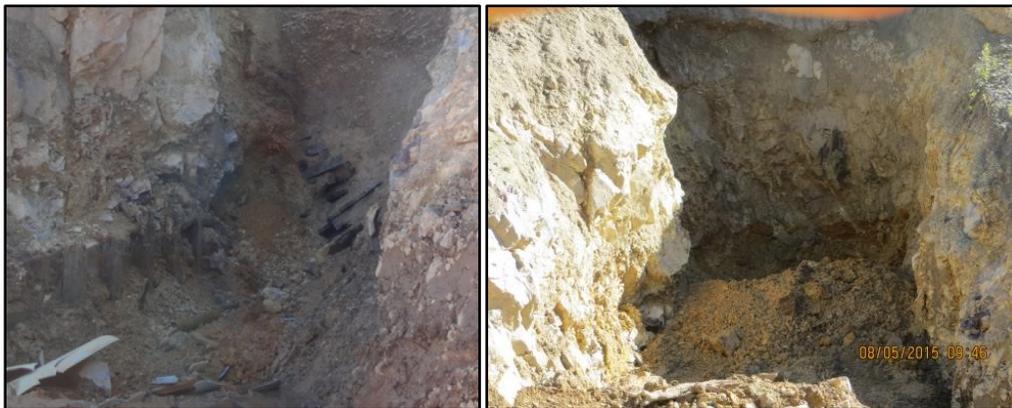
On morning of August 5, 2015, the plug is still visible (left). Shortly thereafter, it was buried with backfill (right). Source: Environmental Restoration/EPA.

After revealing the plug on the afternoon of August 4, the EPA crew paused overnight to consider the situation. The following day, they continued excavating. Photographs of the work performed at the site on the morning of August 5 appear to show that EPA removed the remaining portions of the DRMS pipes closest to the portal and then backfilled the excavated area until the plug they had exposed the day before was hidden behind a mound of backfilled earth.

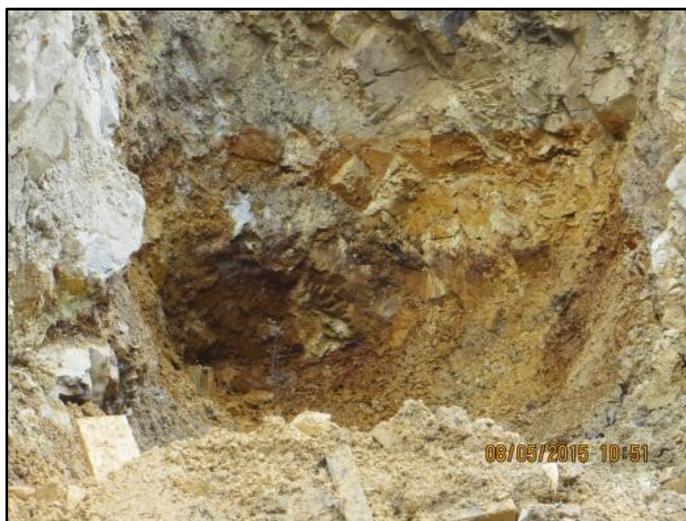
The initial spurt of water from the adit appears in the excavated area, just below a white mark on the rock face. The plug is no longer visible because EPA backfilled the excavation. Source: EPA.

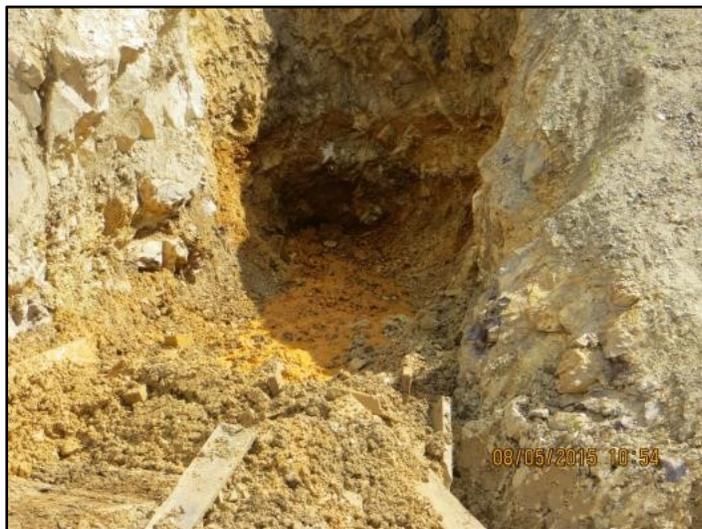
The flow of water escaping from the adit has increased and turned orange. Wood planks, placed to direct water towards the channel on the right side of the adit, are also visible. Source: EPA.

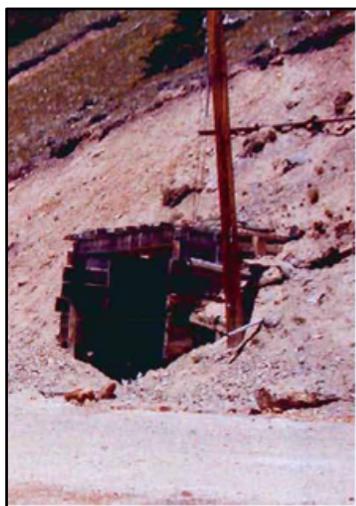
The portal structure, prior to DRMS's work. Source: DRMS.

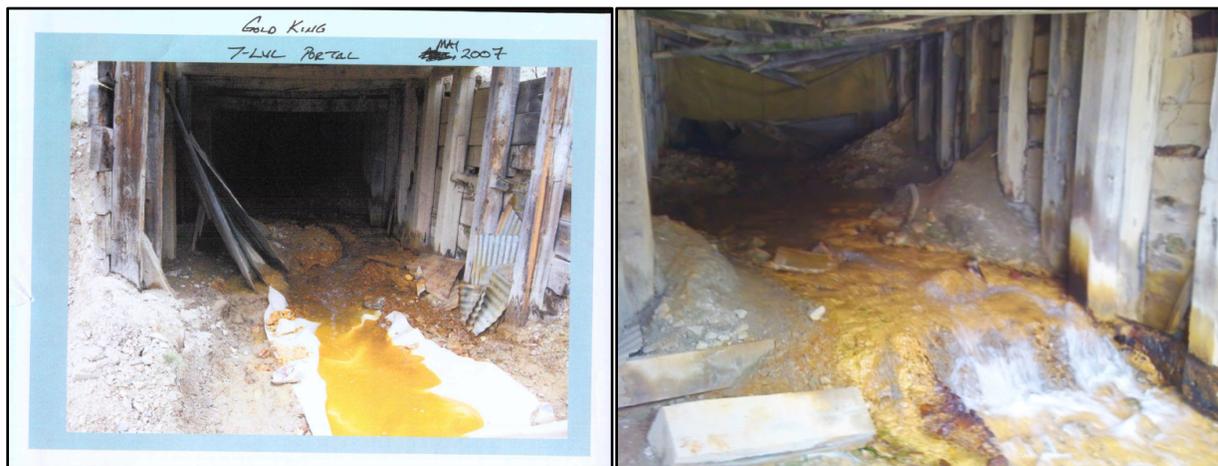
Photographs showing the adit in 2007 (left) and 2009 (right). Source: DRMS (left), Todd Hennis (right).

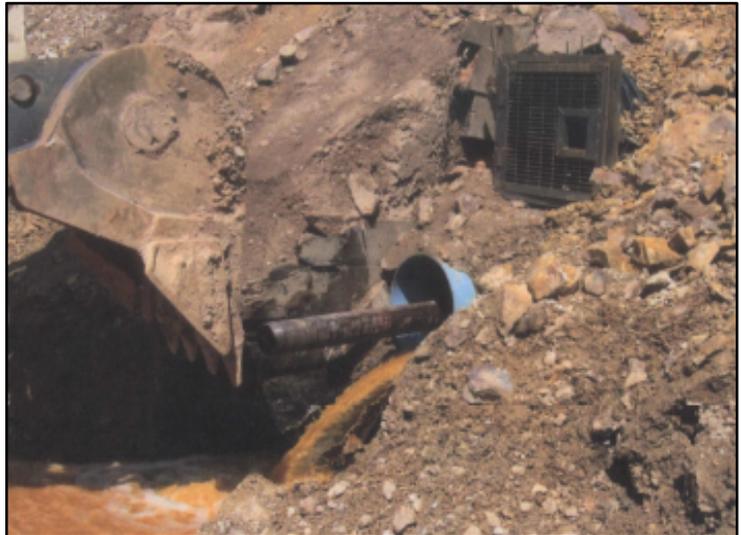
DRMS drives the stinger through the drainage pipe in 2009.
Source: DRMS.

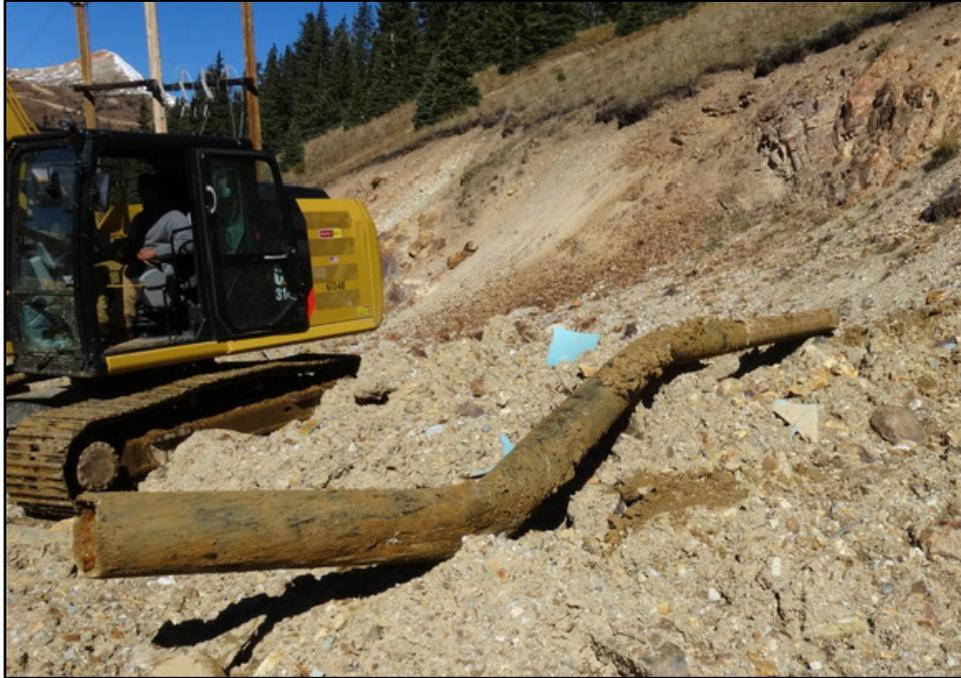
Part of the stinger, following removal in 2014. Source: Environmental Restoration.

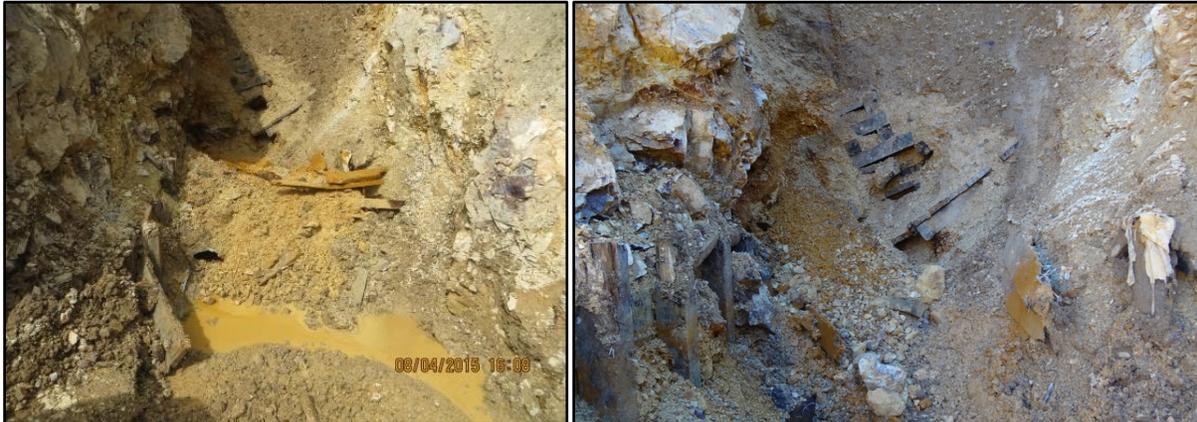
The plug on the afternoon of August 4 (left) and the morning of August 5 (right). Source: EPA (left) and Environmental Restoration (right).

Photographs of the excavated adit show what appears to be wooden debris from the portal structure embedded in the plug. The top of the plug is clearly visible above the level of the drainage and observation pipes. When the crew discovered that the plug was above where EPA's 2014 conclusions indicated it would be, it should have been a clear warning to the EPA crew that their assumptions were incorrect. It also removed the crew's basis for assuming the adit was not pressurized, since that assumption rested primarily on the EPA's (now disproved) beliefs about the location of the adit floor.

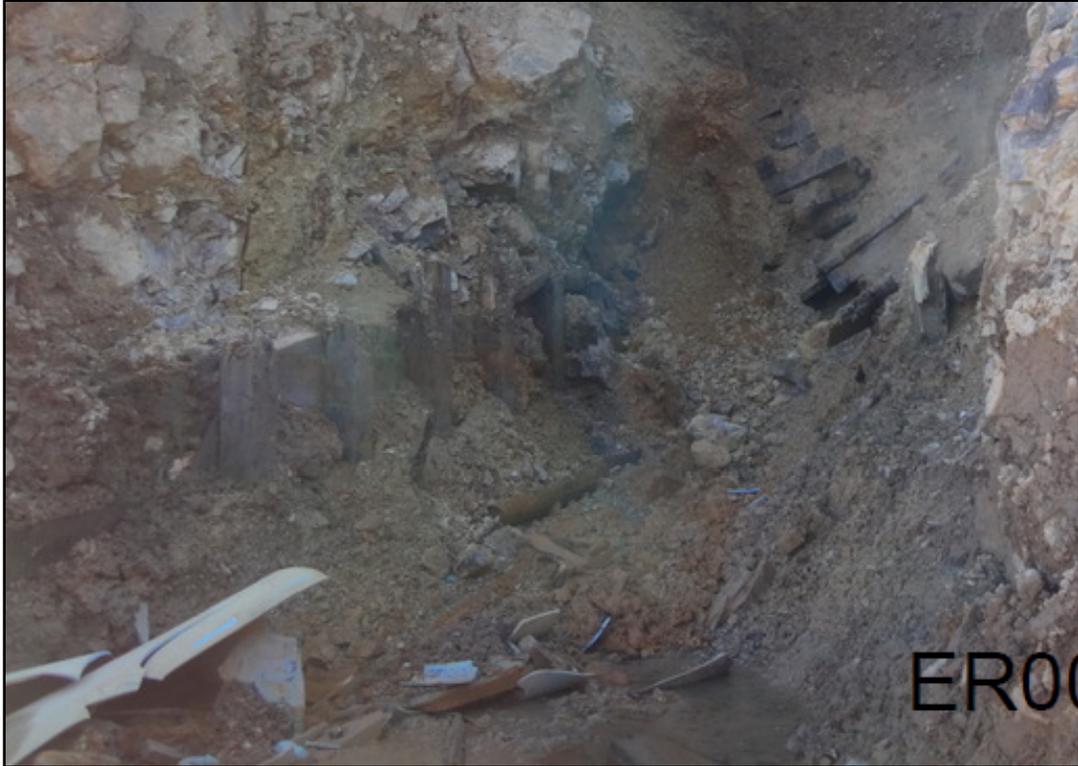
Shards of the removed drainage pipe (lower left) in front of the excavated adit. Source: Environmental Restoration.

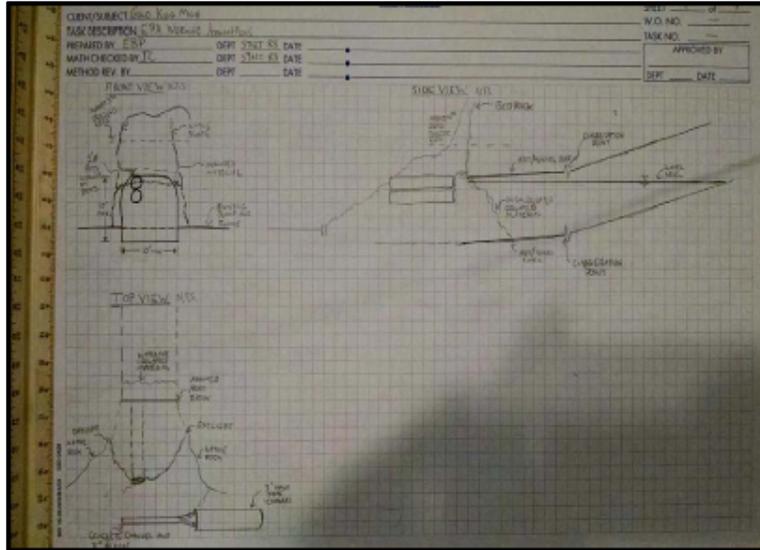
The contractor's August 11, 2015, drawing of EPA's "working assumptions" about the Gold King Mine, included in the *Internal Review* as Attachment D. Source: EPA.

Despite EPA's conclusion that the adit floor was six feet below the surface of the waste dump, and EPA's reassertion of this conclusion in its *Internal Review*, the drawing that EPA attached to illustrate the crew's working assumptions is curiously ambiguous regarding the elevation of the adit floor. The line depicting the adit floor fades away well before the point at which it would connect to the waste dump surface.

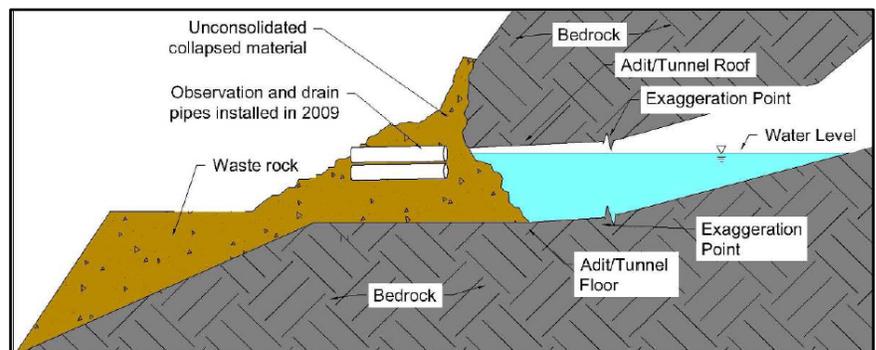
Figure 40.—Cross-section illustration showing the condition of the adit that was assumed by the EPA OSC and the abandoned mine experts from DRMS for use in planning to open the adit (not to scale). The “exaggeration point” means the right side of the drawing has an exaggerated vertical scale in order to show the 1% uphill slope of the adit. If drawn without exaggeration, the uphill slope of the adit would not be obvious on the drawing.

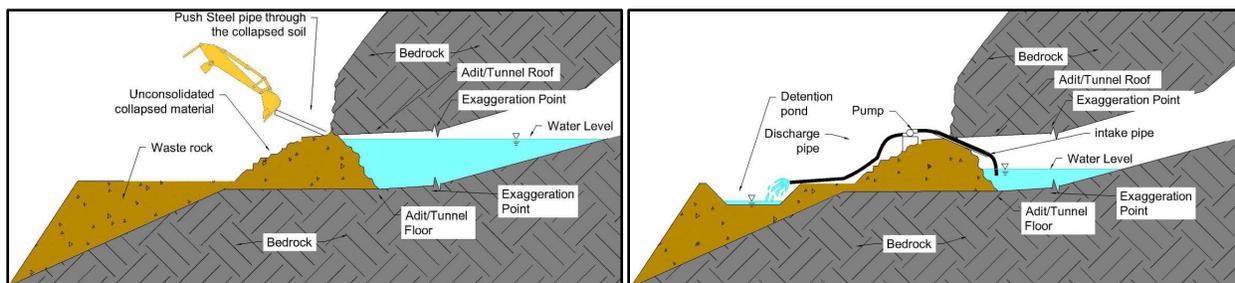
Figures 42 (left) and 44 (right) in DOI’s *Technical Evaluation* depict steps 2 and 4 of the plan EPA was supposedly implementing when the blowout occurred. EPA could not have been following this plan, because the steel pipe (stinger) and pump were not on-site on August 5, 2015.

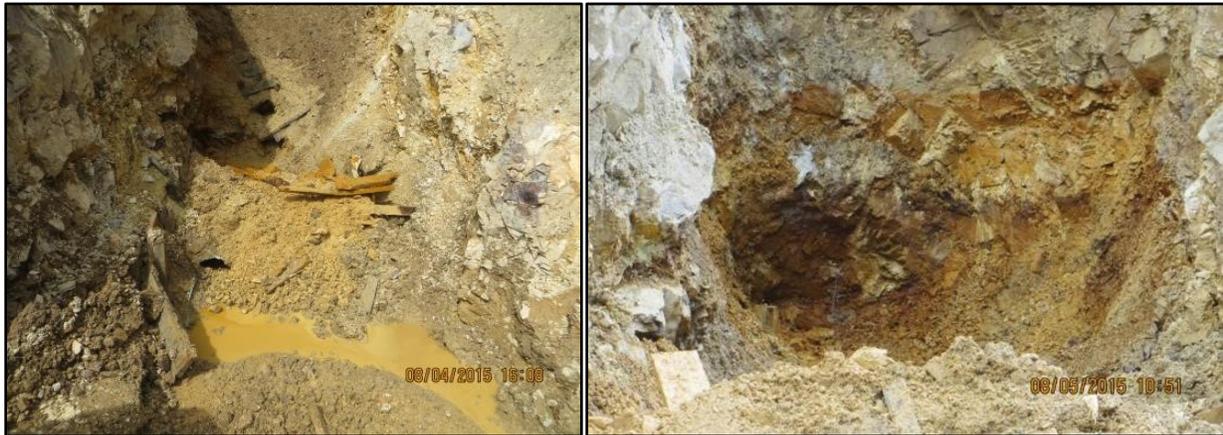
with and keep dirt from falling on the plug, the EPA crew had almost entirely buried the plug when they backfilled the excavation to near the top of the adit. As a caption from the *Technical Evaluation* noted, “[t]he fill derived from the excavation had now covered the timbers, lagging, and seep visible in the previous photograph.”²²⁷ Mr. Griswold gave a video account of what happened the day of the blowout stating, “There’s pictures of that, that we have.”²²⁸ Following are two of the pictures Mr. Griswold refers to.

Plug exposed on August 4 (left), and buried by backfill at the time of the initial spurt (right). Source: EPA.
