**Statement of Tom Partin, President
American Forest Resource Council**

**Legislative Hearing on H.R. 3188
October 3, 2013**

**The Impact of Catastrophic Wildfires on Watersheds, such as the Rim Fire, Stanislaus
National Forest**

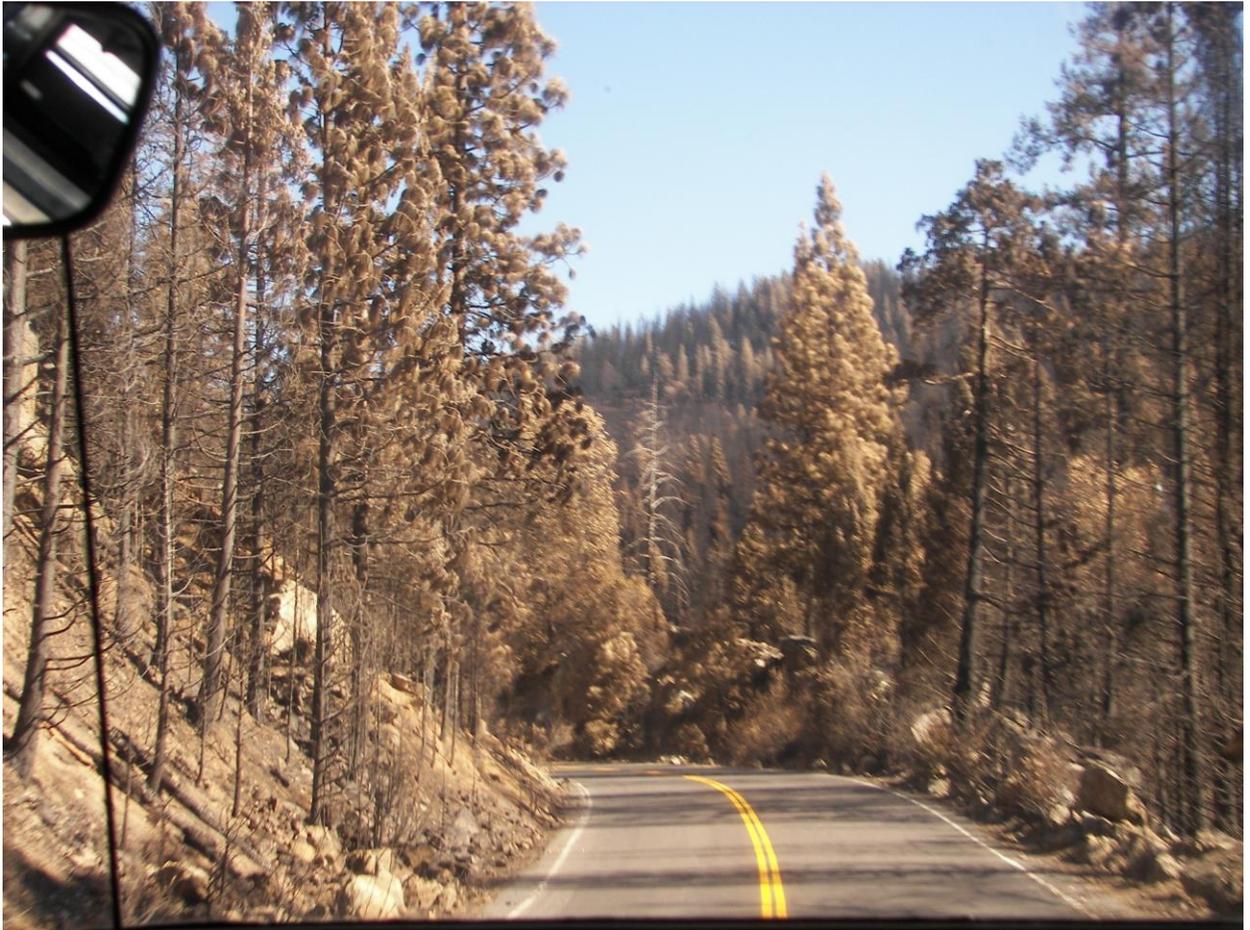
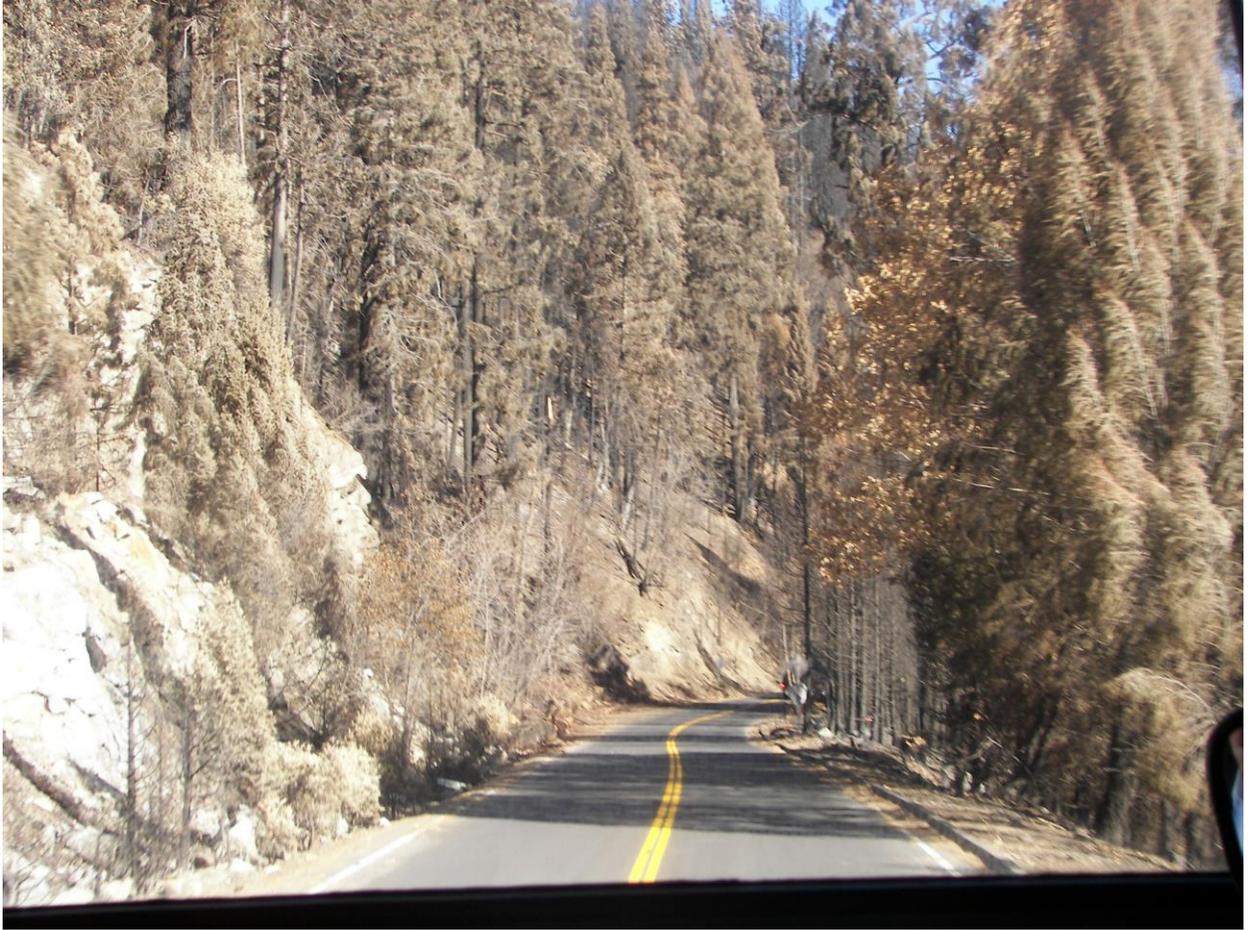
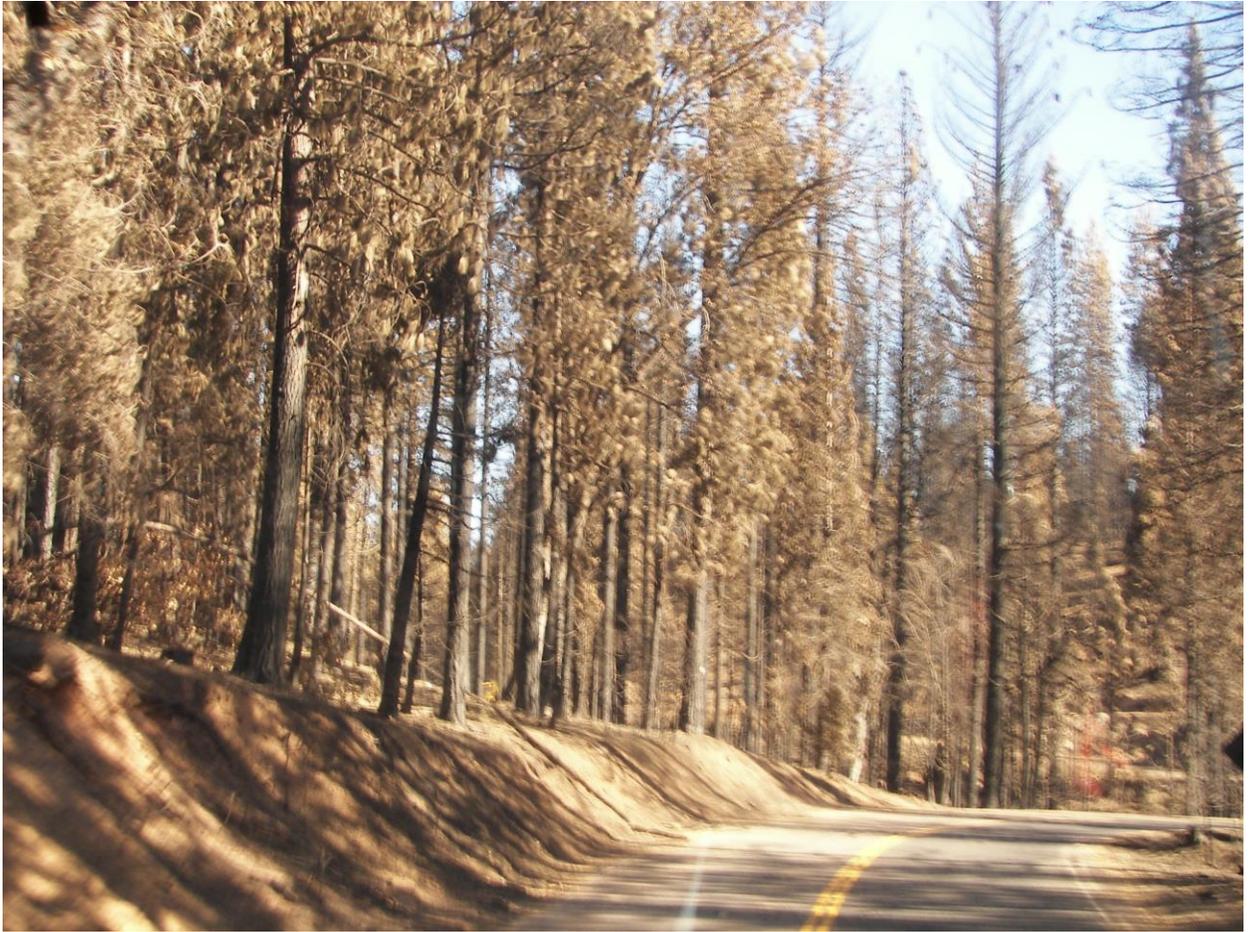
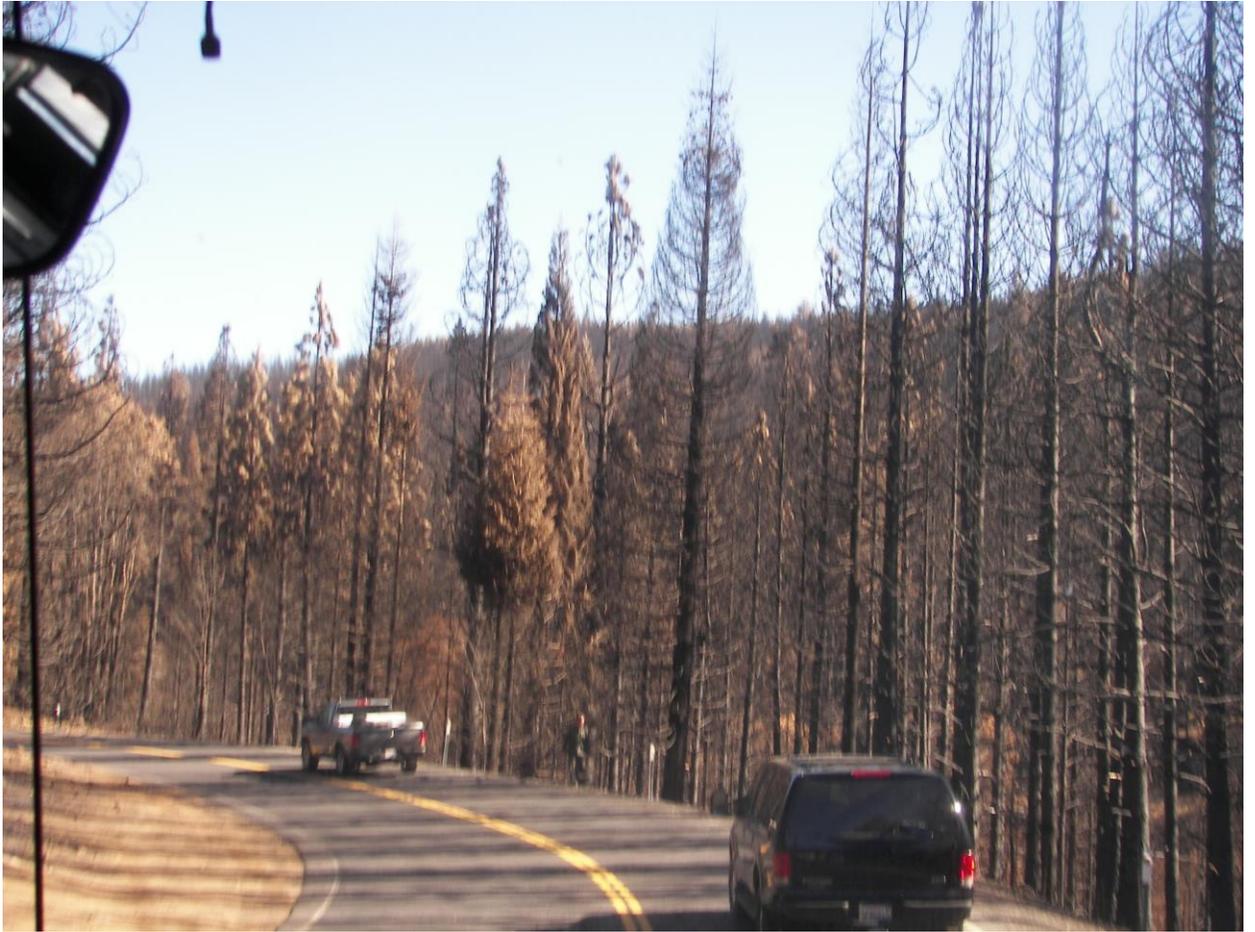
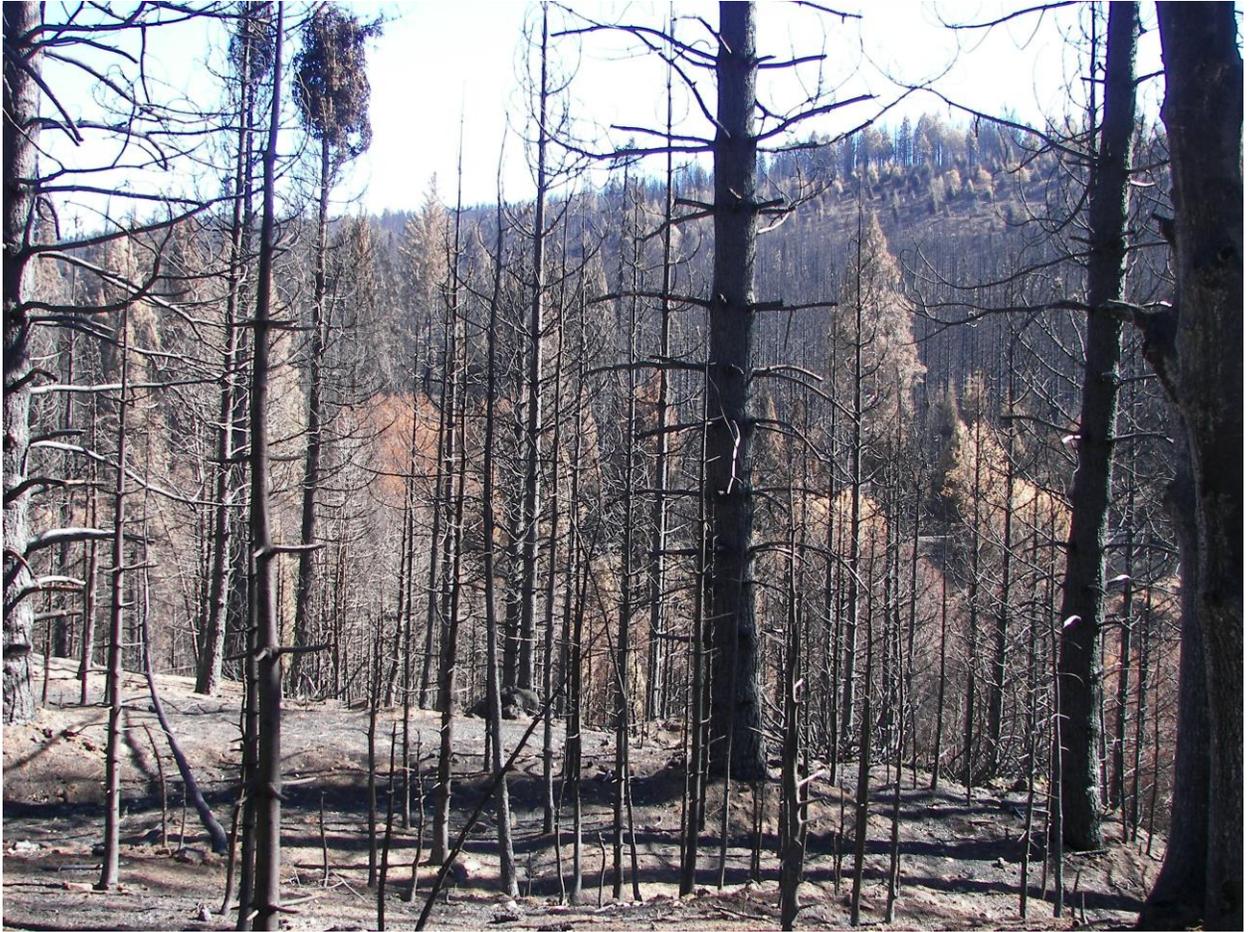
Pictures Taken along the Cottonwood Road within the Burn Perimeter of the Rim Fire, Stanislaus Natl. Forest – Pictures taken Sept. 26, 2013

Much of the existing road system has inside ditches; in just 2 weeks during the fire, dry ravel off the cut banks already filled miles of these ditches. On the fill slopes following the fire, dry ravel is eroding the fill slopes and exposing the pavement and crushed aggregate base on the mainline roads.
