EPA, THE DEPARTMENT OF THE INTERIOR, AND THE GOLD KING MINE DISASTER

February 11, 2016
Majority Staff Report
Committee on Natural Resources
Chairman Rob Bishop
U.S. House of Representatives
114th Congress

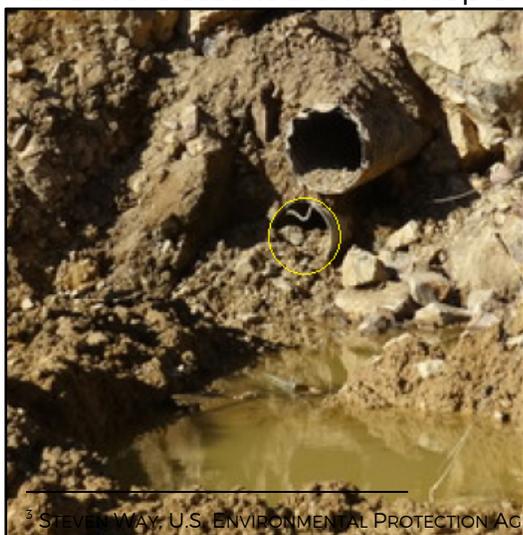
During its brief excavation of the portal in 2014, EPA appears to have misinterpreted the conditions in the adit and incorrectly concluded that the adit floor was six feet below the surface of the waste rock dump. The EPA crew observed “timbers . . . on the sides,” and an EPA contractor reportedly saw “a cap timber.”⁷ Presumably, the EPA crew took into account the adit’s 10 foot maximum height, saw what they assumed were the sides and roof of the portal structure extending about four feet above the waste dump, and concluded that the floor of the adit must have been six feet below the surface of the waste rock dump.⁸ They also assumed that the drainage and observation pipes that DRMS had installed in 2009, which EPA noted were each 24 inches in diameter and were stacked one on top of the other, occupied the top four feet of the

portal structure. In other words, EPA believed that the upper pipe was flush with the adit roof and the lower pipe, the drainage pipe, was close to the elevation of the waste rock dump surface. If that were the case, the remaining six feet of the adit would be below the surface of the waste rock dump.
